2013 5th International Conference on Chemical, Biological and Environmental Engineering
(ICBEE 2013)

2013 2nd International Conference on Civil Engineering (ICCEN 2013)

Out of Plane Behavior of Calcareous Masonry Panels Strengthened by CFRP

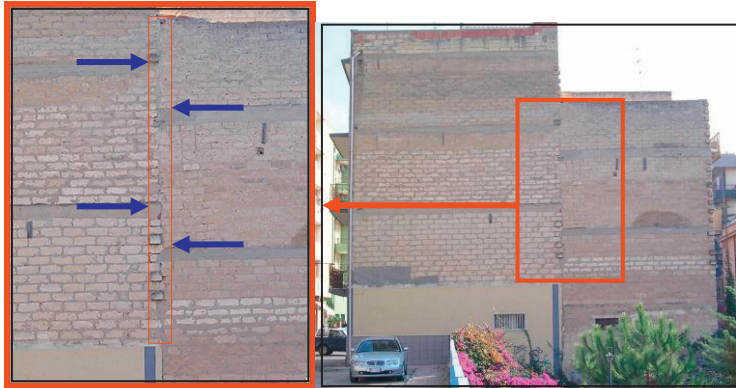
Fig. 1. Collapse mode for combined normal and bending actions

Fig. 2. Out of plane collapse mechanism

propagation and retain structural integrity through increased toughness. The range of testing needs to be increased to determine whether other unknown modes of failure might occur according to different scheme of loads as well as of different mechanical properties of the masonry units used in the masonry heritage. The stability of the wall under dead load depends on the boundary conditions, wall compressive strengths, joint tensile strengths, wall stiffness, and after cracking if they are within the specified height-to-thickness ratio. In this paper we analyzed the effects of the masonry panel well connected to the extremities but under the out of plane actions caused by the presence of roofs located at different levels (Fig.1). Under these conditions, the produced collapse mechanism is that reported in Fig. 2.

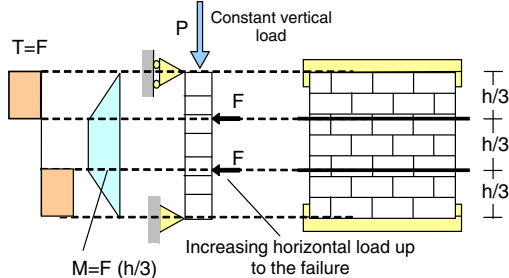
Fig. 5. For points bending test

The statical scheme employed is the typical scheme of a four points bending tests shown in Fig. 5. So a constant bending moment is obtained in the mid portion as well as a constant shear is obtained at the extremities near the supports.

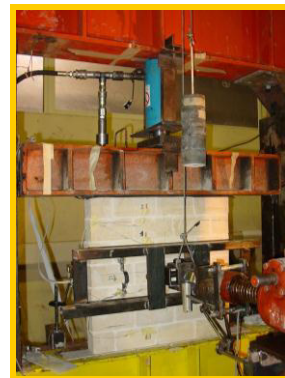
Fig. 6. Testing equipment

Loads were applied cyclically to failure. To reproduce the typical load-bearing walls found in Southern Italy heritage, a uniformly distributed vertical load capable of simulating the gravity service loads typically acting at the lowest storey, was applied. Fig. 6 shows the test apparatus with a specimen ready for testing. A vertical load was applied by a hydraulic jack connected to a tilting beam, restrained in the plane of the rigid frame used for the test, and capable of transferring the load uniformly. The uniform horizontal action was applied on the faces of the specimen by means of two parallel circular profile points spaced $h/3$ from the supports welded onto a rigid bucket as shown in fig.7. The Ω transducers, LVDTs, strain gauges and a load cell were used to monitor the response of the specimens to the applied loads: mid-span deflection, strains on the panels ect.. Readings of load, displacements and deflections were recorded by a computerized UPM60 data acquisition system and stored in an Excel spreadsheet file.

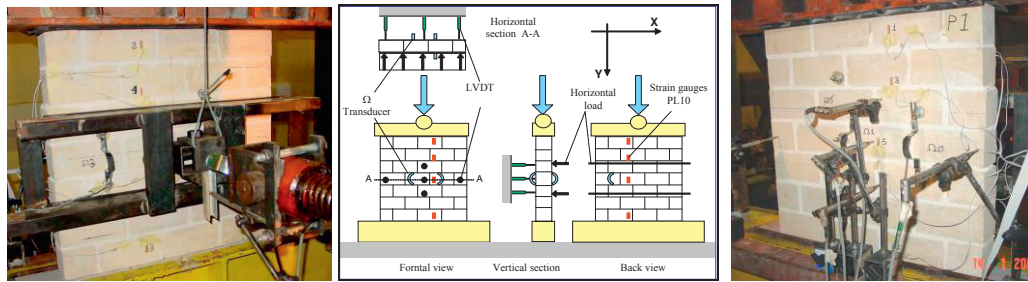
Fig. 7. Instruments disposition in the URM panels

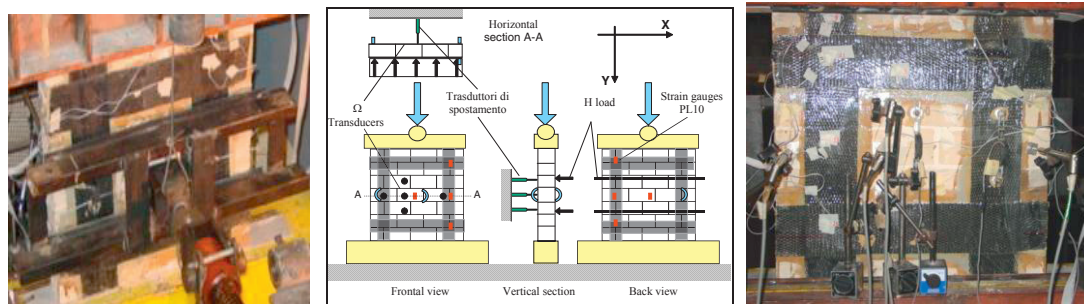
Fig. 8. Instruments disposition in the strengthened panels

In the strengthened specimens, the CFRP layer were applied as a grid of single layer uniaxial carbon/epoxy composite laminate 100 mm wide with a step, in both the directions, chosen, according to the CNR-DT 200/2004 Italian code, by the formula (1), where “ b_f ” is the width of the adopted strengthening system and “ t ” is the thickness of the panel. The CFRP was applied on each side of the wall. The panel was instrumented similarly to URM sample. Testing equipment is shown in Fig. 8.

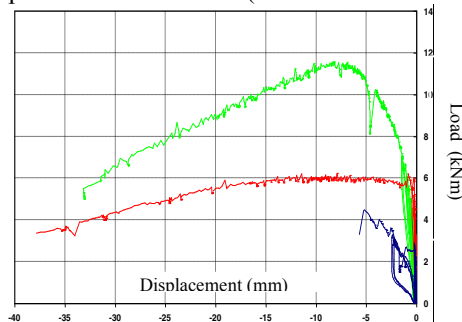
Fig. 9. Load vs displacement URM panels

In the case of a higher vertical load, which acts as a stabilizer, the load displacement curve (Fig. 9) gives an apparent high ductility with an ultimate displacement up to 40 mm and a horizontal reagent load of 5kN; when the stabilizing load decreases the panel shows its weakness. The collapse occurs for very low out plane loads. In fact, the restrain conditions at the extremities and the magnitude of the stabilizing load produce the formation of a three-hinged arch, of variable position in the thickness of the masonry, which must be aligned so as to form a mechanism (Fig. 10). By considering a vertical load corresponding to a real vertical load

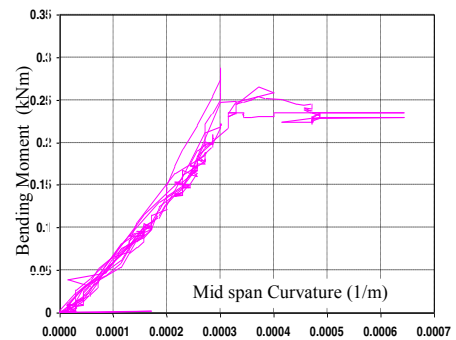
Fig. 11. Bending vs Curvature URM

acting on the structure, in the reduced scale, equal to 3 kN, the panels fails under a very low ultimate bending equal to 0,28 kNm. (Fig. 11).

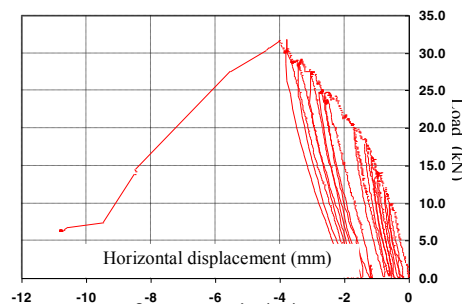
Fig. 12. Load vs displacement CRM panels

Three specimens were tested under a vertical constant load of 3,0 kN, corresponding to the real load acting on a masonry. The tests were carried out cyclically up to the collapse. The stiffness in the load displacement curve (Fig. 12) slowly degrades up to a peak of the collapse moment. This behavior is mainly due to the failure mode of the specimen; in fact collapse does not occur in the central area because of the achievement of the ultimate bending in this section, but near the supports where the slip between the bricks and a debonding of fibers occurs (Fig. 13). The shear failure is a fragile collapse mode, that occurs before the more ductile flexural mode, is due to the presence of the applied CFRP reinforcement. The elastic flexural behavior can be analyzed in Moment curvature plot of Fig. 14 where it is possible to note the cycles overlapping under an out plane action of 20 kN (2/3 of the ultimate load).

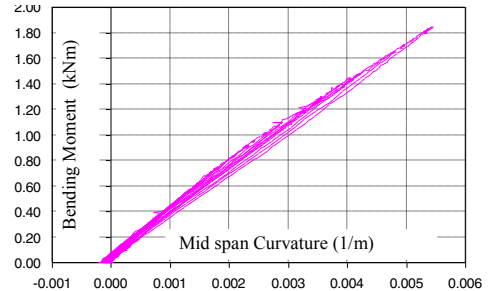
Fig. 14 Bending vs Curvature CRM
